Evaluation of Optical Materials Samples

FINAL REPORT

University of Dayton
Research Institute
Dayton, Ohio 45469

JULY 1988

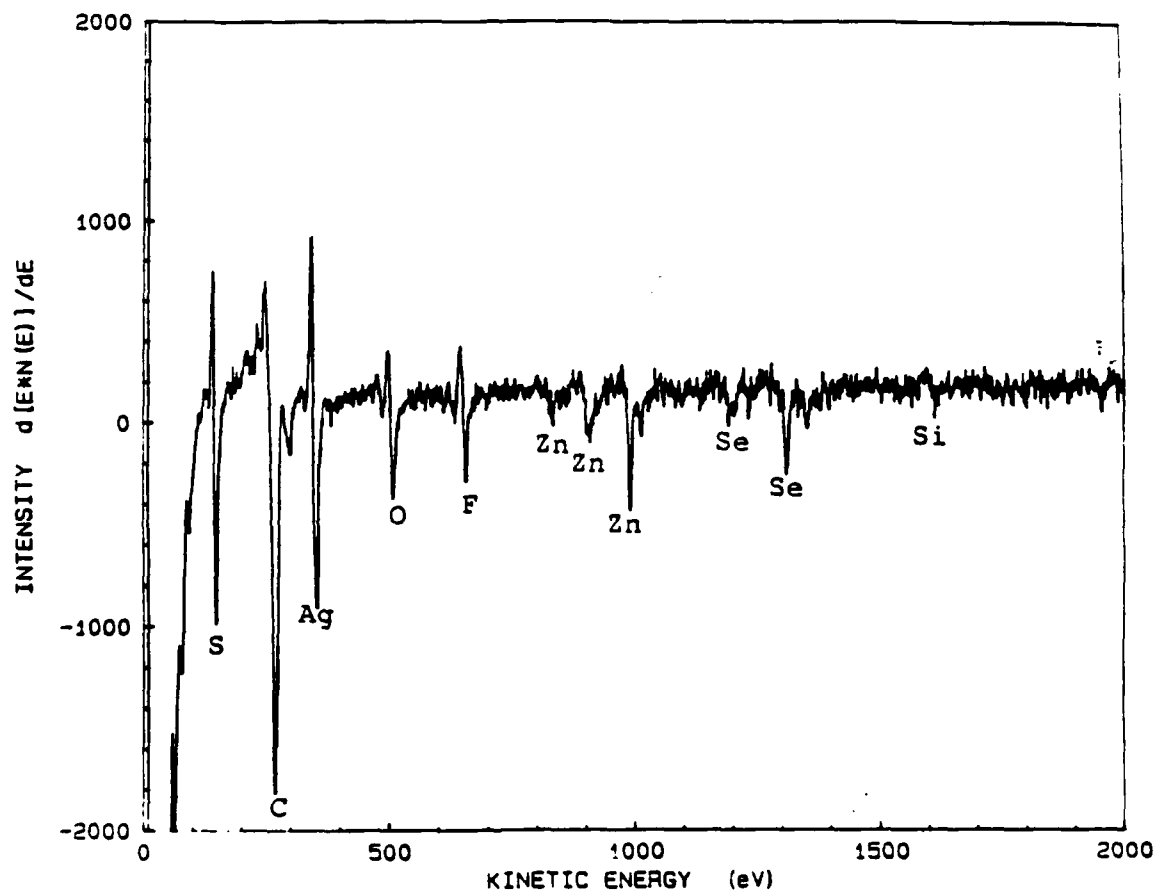
6-3788-2. DAMAGE DEBRIS WITHIN CRATER #2

Once it was established that the ZnSe layer was subject to electron and ion beam damage with no apparent acceptable damage threshold for Auger analysis, parameters were chosen which minimized the beam effects in the ZnSe film. A damage crater designated crater #2 was chosen. Figure 7 is an Auger spectrum taken from within this crater. Sulfur, carbon, silver, oxygen, fluoride, zinc, selenium, and silicon are observed. Sulfur, carbon, and oxygen are most likely from ordinary environmental contamination as a

Figure 7. An Auger spectrum from inside crater #2 just below the central pit. The absence of thorium is significant.

result of handling. Zinc and selenium are from the outermost optical coating. The presence of silver and fluoride along with the absence of thorium is curious.

inner most layers which would end up inverted within the crater debris near the rim. This cratering mode of failure would explain the presence of silver in the crater debris spectrum shown in Figure 7. Depending on temperatures during failure, localized melting of the silicon substrate could occur leaving an uneven surface after resolidification.

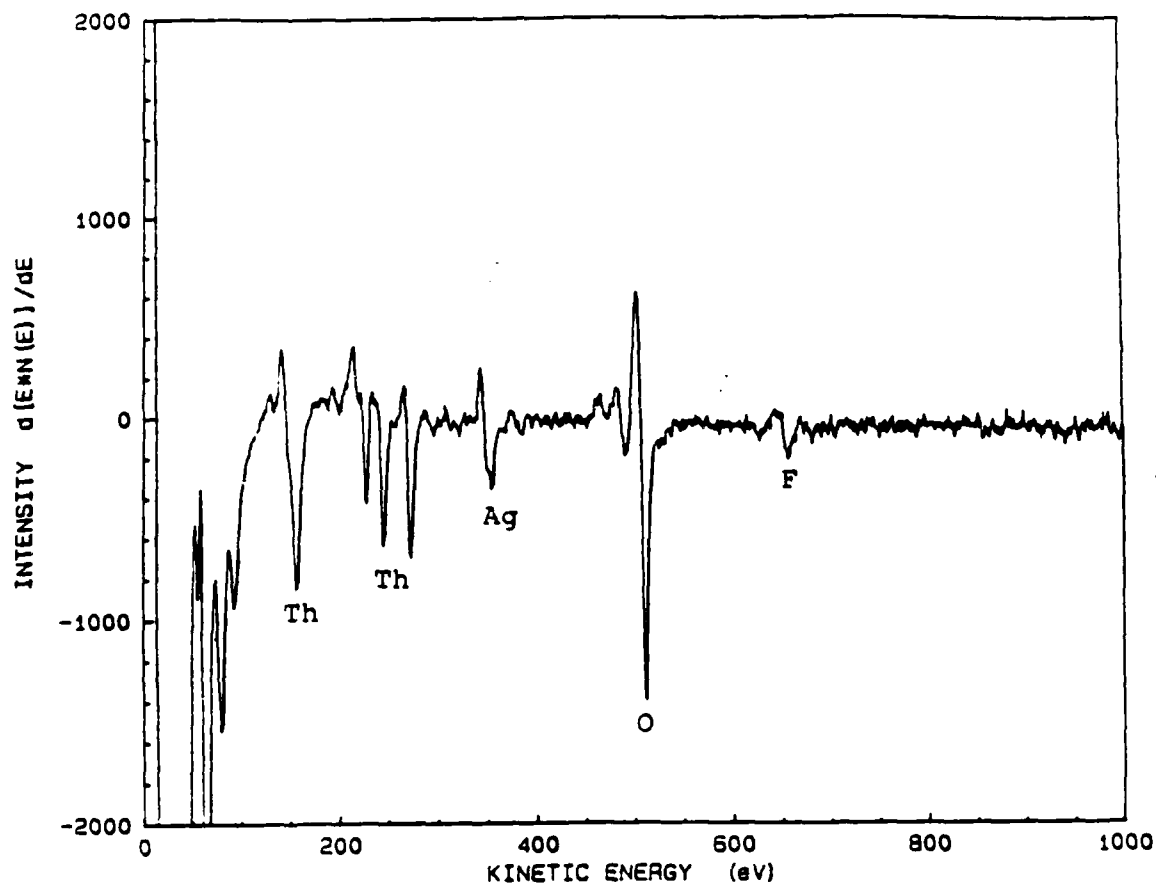
6-3788-2. FAR LEFT REGION OF LINE SCAN

Figure 9. An Auger spectrum from the far left portion of Figure 8 along the line scan.

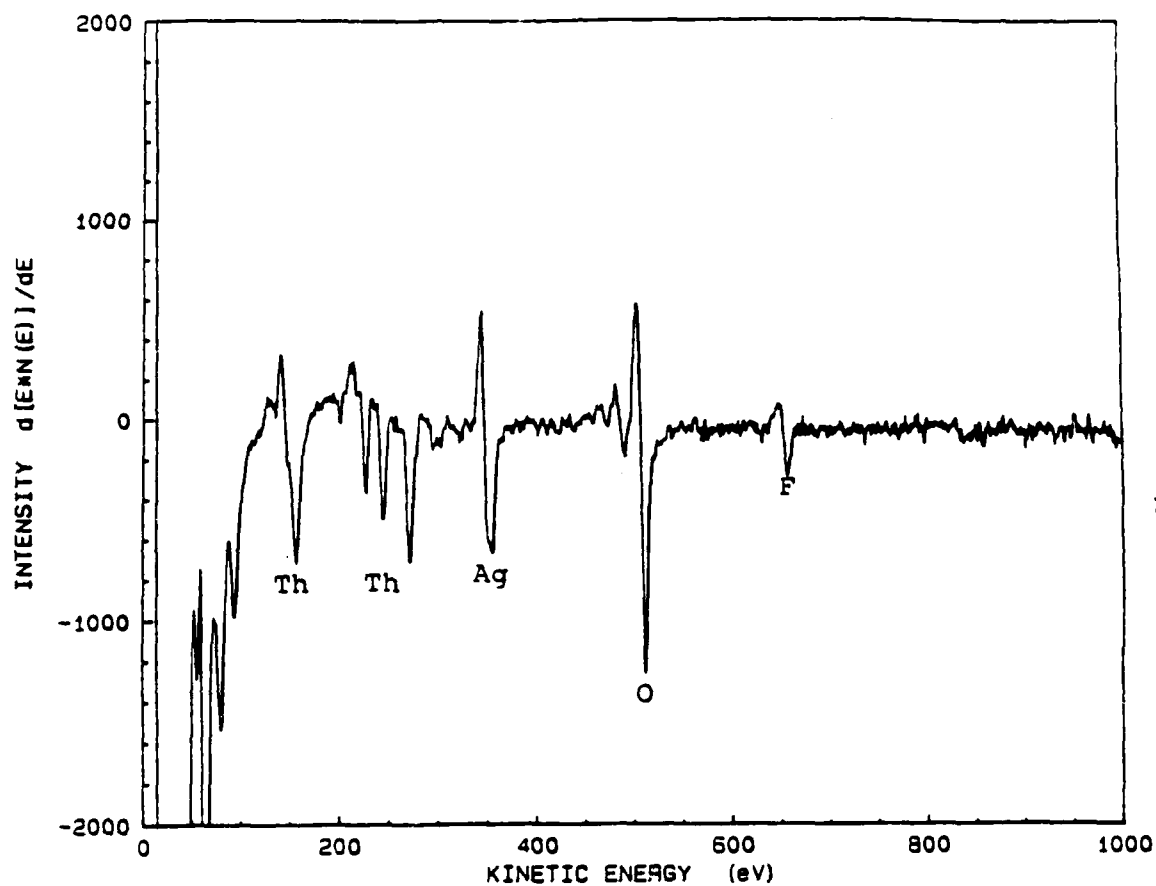
6-3788-2, LINE SCAN, LEFT RIM OF CRATER

Figure 10. An Auger spectrum from the left rim of crater #2 along the line scan.

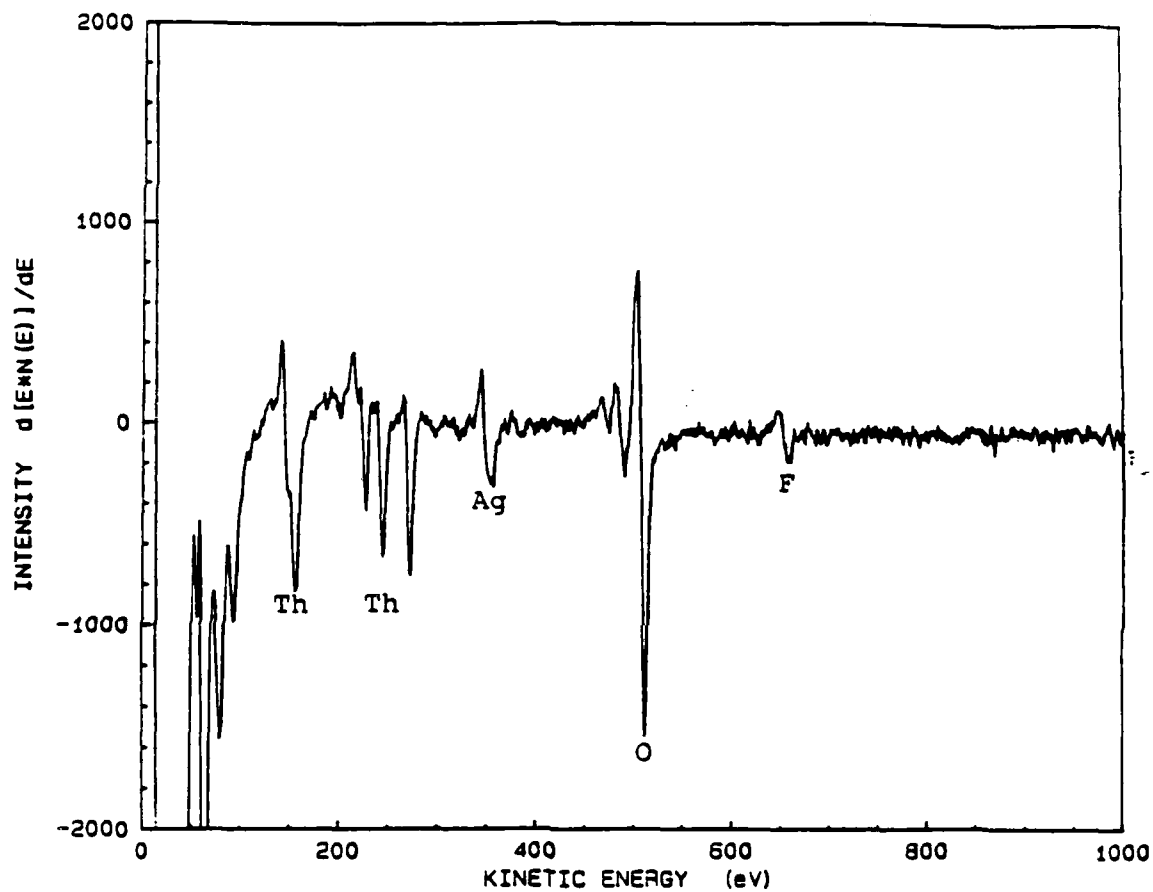
6-3788-2, WITHIN CRATER, BELOW CENTER OF LINE SCAN

Figure 11. An Auger spectrum from within the perimeter of crater #2 just below the central pit.

We conclude from Table 1 that the oxygen level is artificially high and probably results from exposure to oxygen during catastrophic failure as well as from oxygen gettered from the Auger vacuum system. The fluoride level is most definitely reduced by the Auger analysis and may also be further reduced during catastrophic failure if temperatures reach excessive levels. It is interesting to note that the fluoride level increases as the silver fluoride compound may be a reaction product in this failure mode. This could also explain the presence of fluoride in Figure 7 where thorium is not detected.

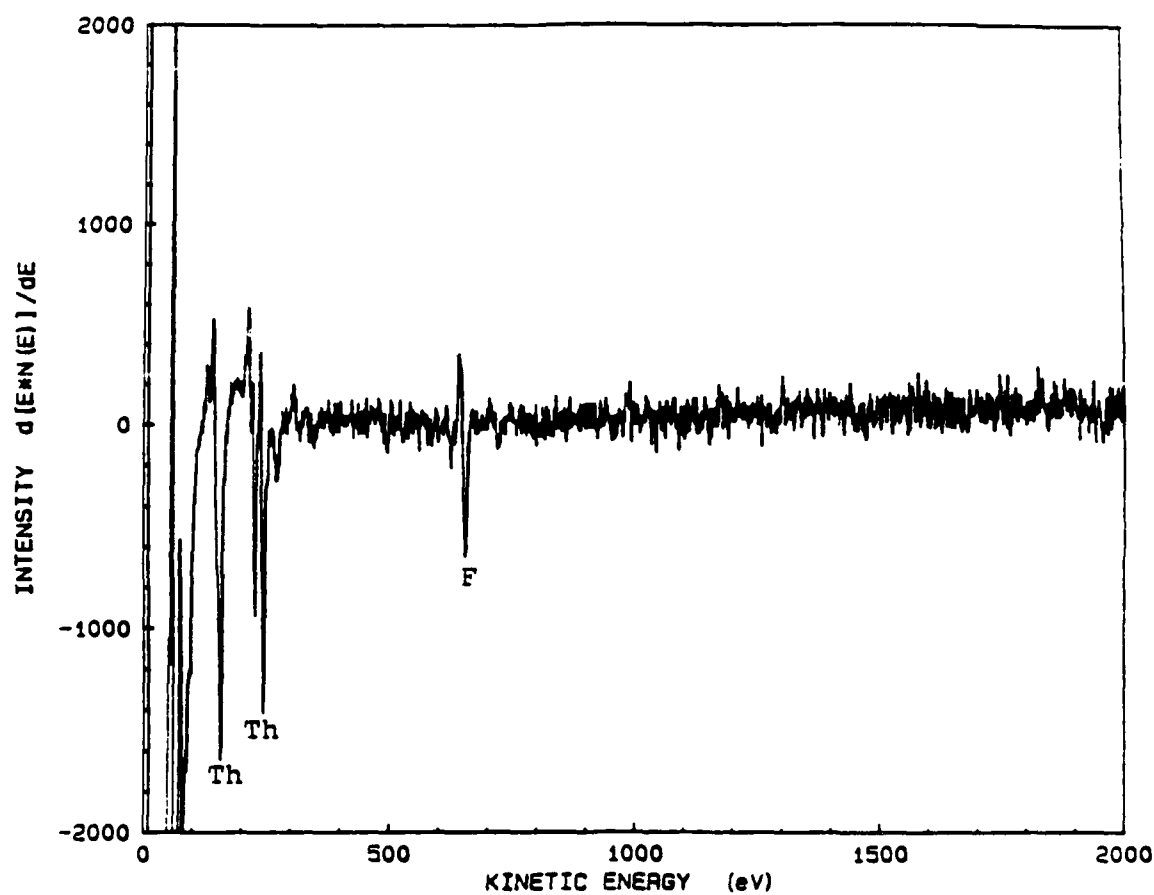
6-3788-02. THORIUM FLUORIDE WHILE SPUTTERING

Figure 12. An Auger spectrum of ThF_4 immediately after the ion beam was turned off. Note the absence of oxygen which would occur near 510 eV.

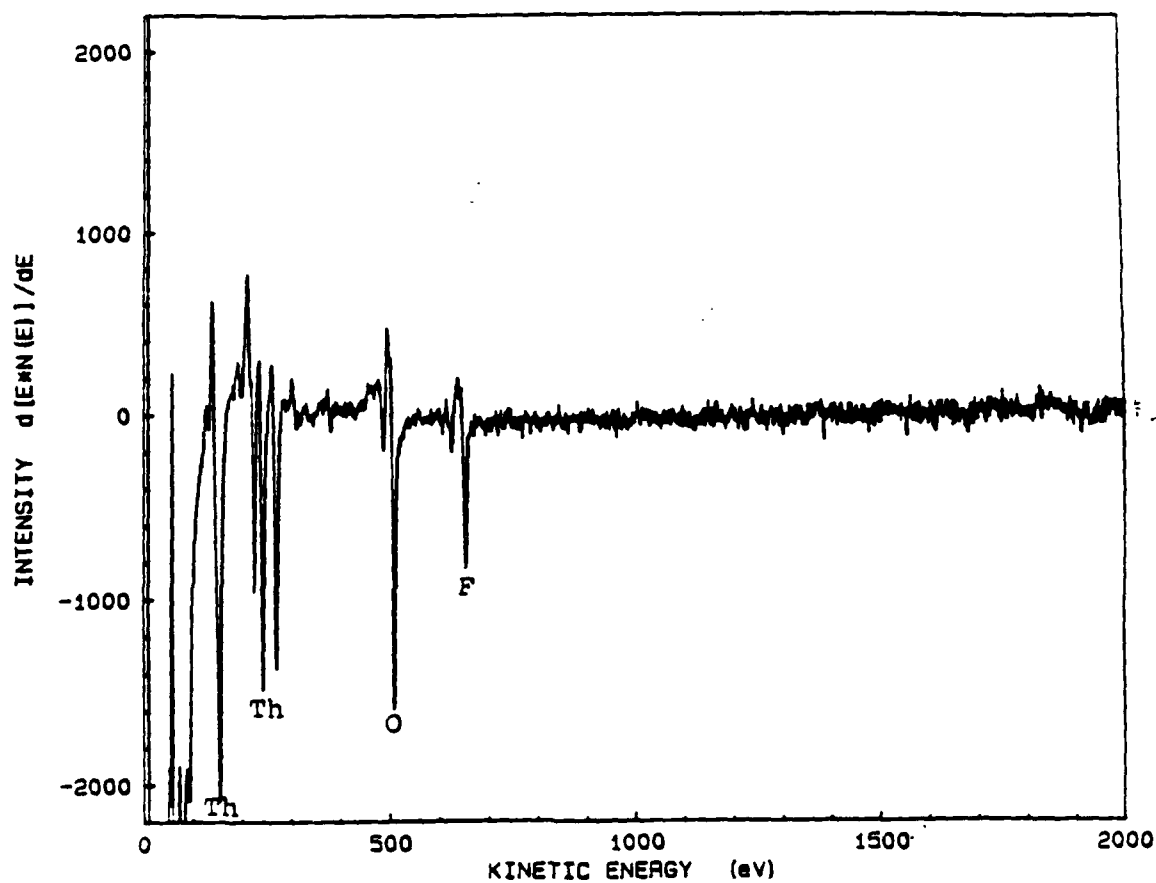
6-3788-02. THORIUM FLUORIDE. ION GUN OFF

Figure 13. An Auger spectrum of ThF_4 immediately after the ion beam was turned off. Note the large oxygen peak at 510 eV.

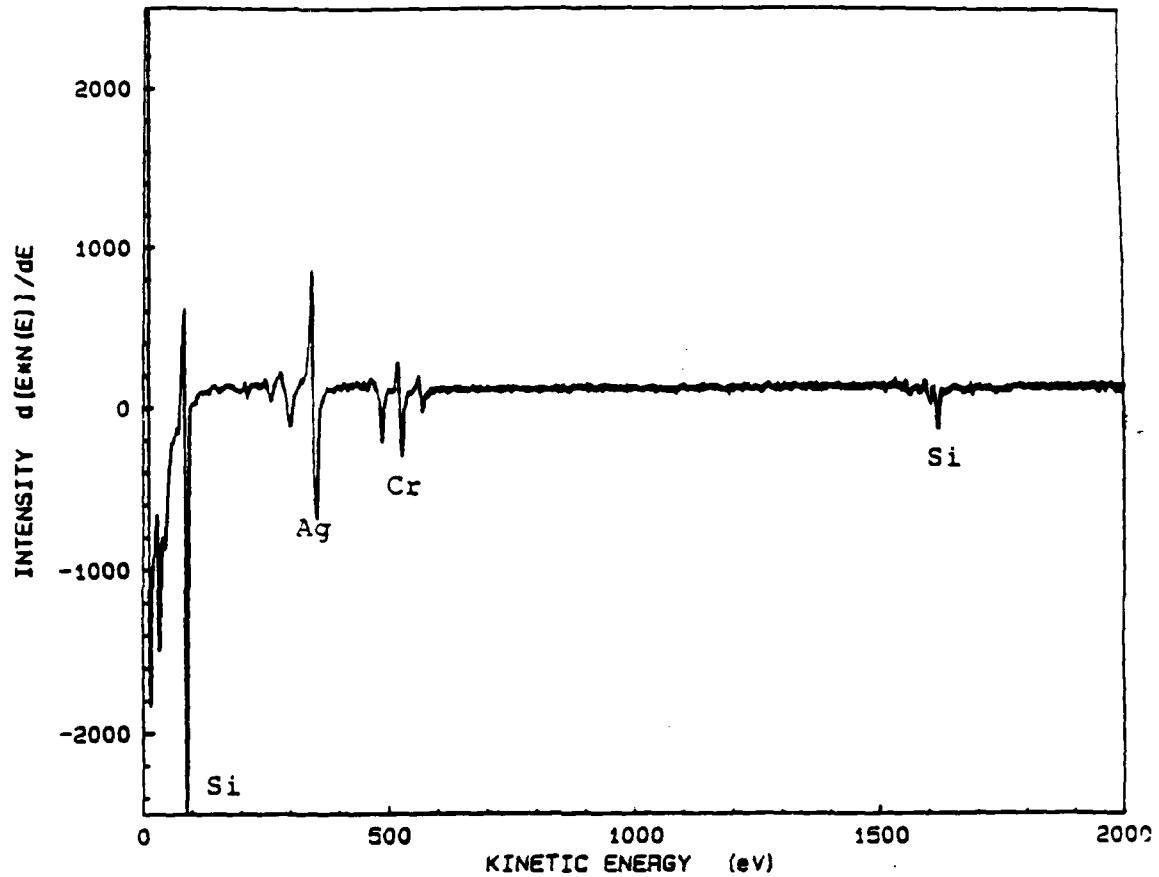
6-3788-2. AG/CR/SI INTERFACE IN CRATER #2

Figure 14 shows crater #2 at the silver/chromium/silicon interface. Figure 15 is an Auger spectrum taken inside the crater rim. Silver,

Figure 15. An Auger spectrum from within the crater rim just below the central pit. Silicon, chromium, and silver are present.

chromium, and silicon are present. The light colored region outside the crater is silver as shown by the Auger spectrum in Figure 16. It is interesting to note that silicon and chromium are seen within the crater and only silver is seen outside the crater even though both regions were sputtered for the same period of time. This suggests that most of the silver was expelled from the crater during failure. This is consistent with the Auger results. The gray region near the right and left hand edges of Figure 14 is the ThF_4 film. It appears that some blistering has occurred. Whether this is significant is unknown. This damage could very well be caused by the ion beam.

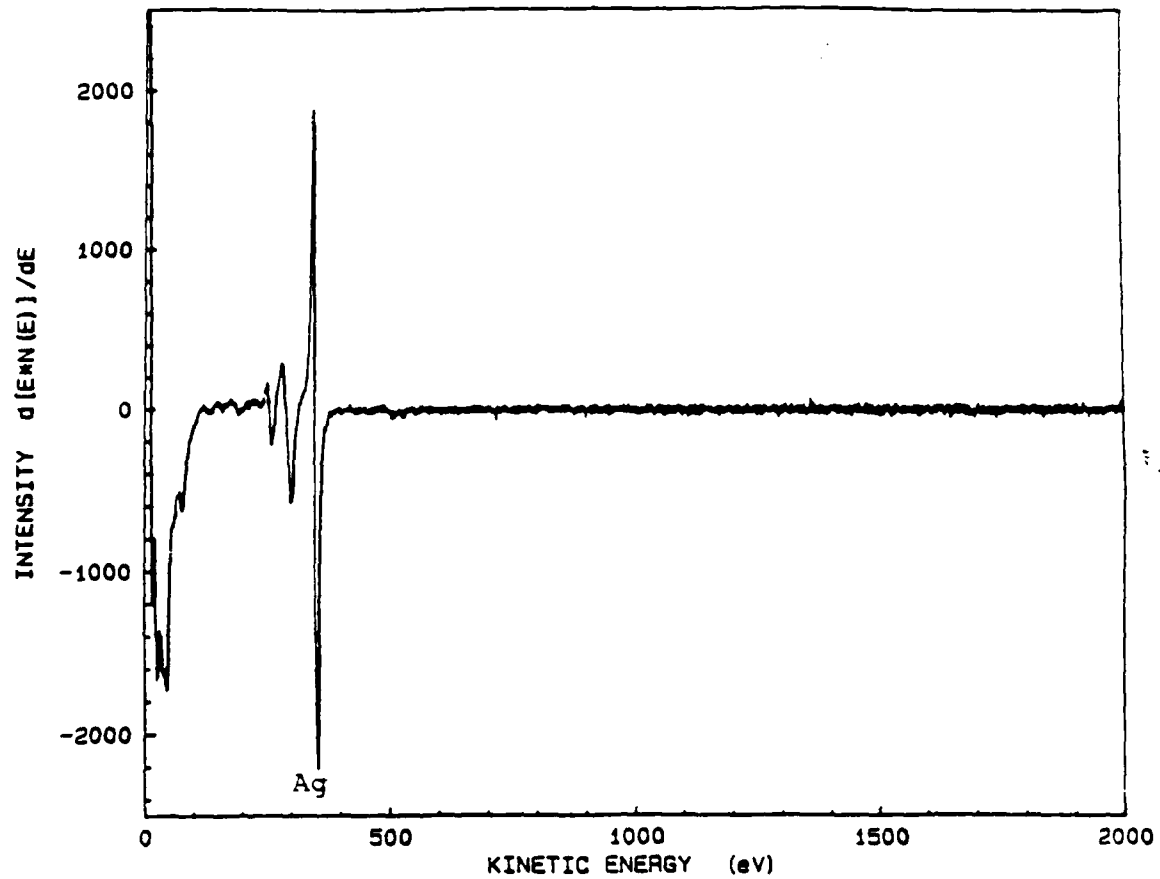
6-3788-2. SILVER FILM ABOVE CRATER #2

Figure 16. An Auger spectrum taken from a region above the damage site. Silver is the only element present.

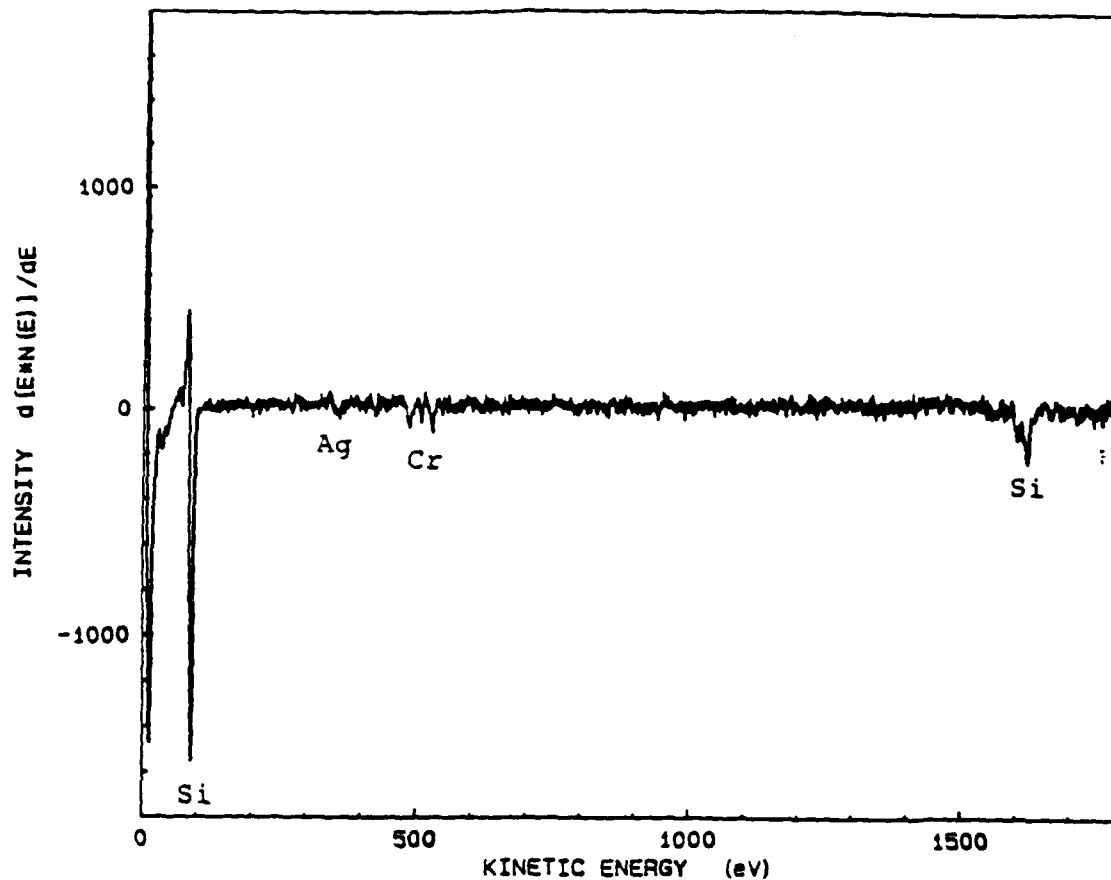
6-3788-2. CENTER FEATURE IN CRATER #3

Figure 21. An Auger spectrum of the central feature in Figure 20. Silver, chromium, and silicon are present and perhaps have alloyed as a result of heat generated during failure.

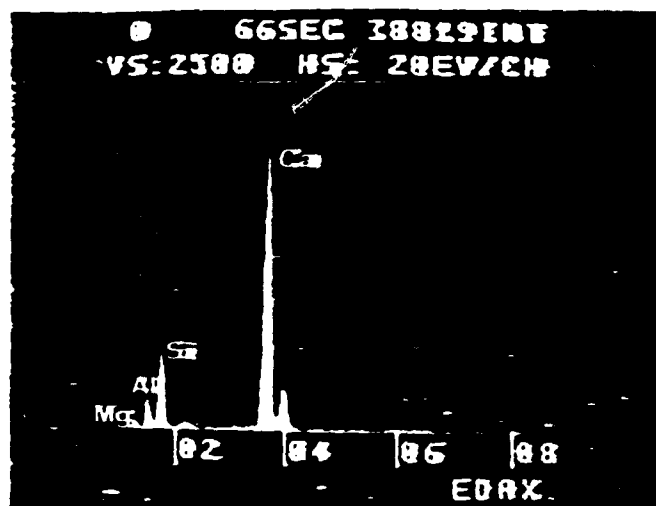
In an effort to determine the chemistry of the white substance, scanning electron microscopy (SEM), x-ray diffraction (XRD) with an energy dispersive x-ray analyzer (EDAX), and Auger electron spectroscopy examinations were made on the materials involved. The SEM, EDAX, and XRD studies confirmed that the porous material was composed of Si and Ca with traces of Mg, Al, K, Mn, and Fe, but nothing more in the way of elements higher in atomic number than Na (atomic number 11) (Figures 25 and 26). The elements were assumed to be present in the SiC raw material or in the cooling water.

Figure 25. EDAX scan of porous SiC and contaminant showing the presence of Mn, Ca, Si, and Al.

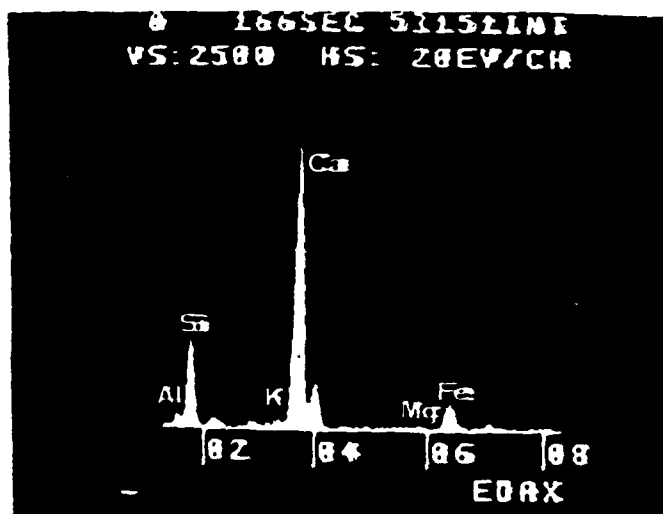
Figure 26. EDAX scan of porous SiC and contaminant showing the presence of Al, Si, K, Ca, Mg, and Fe.

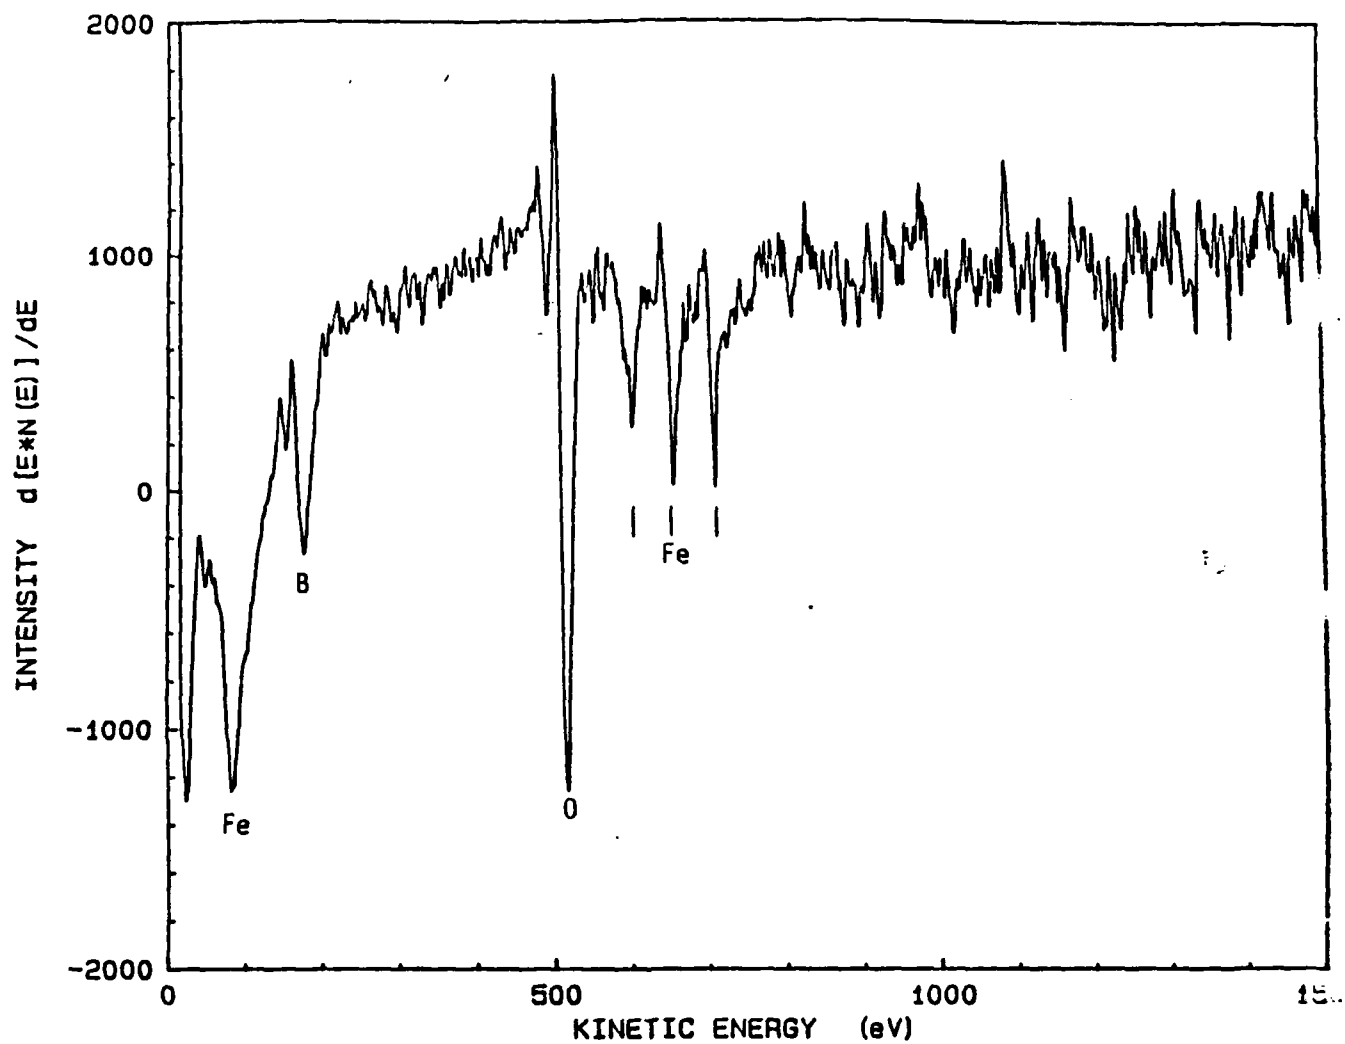
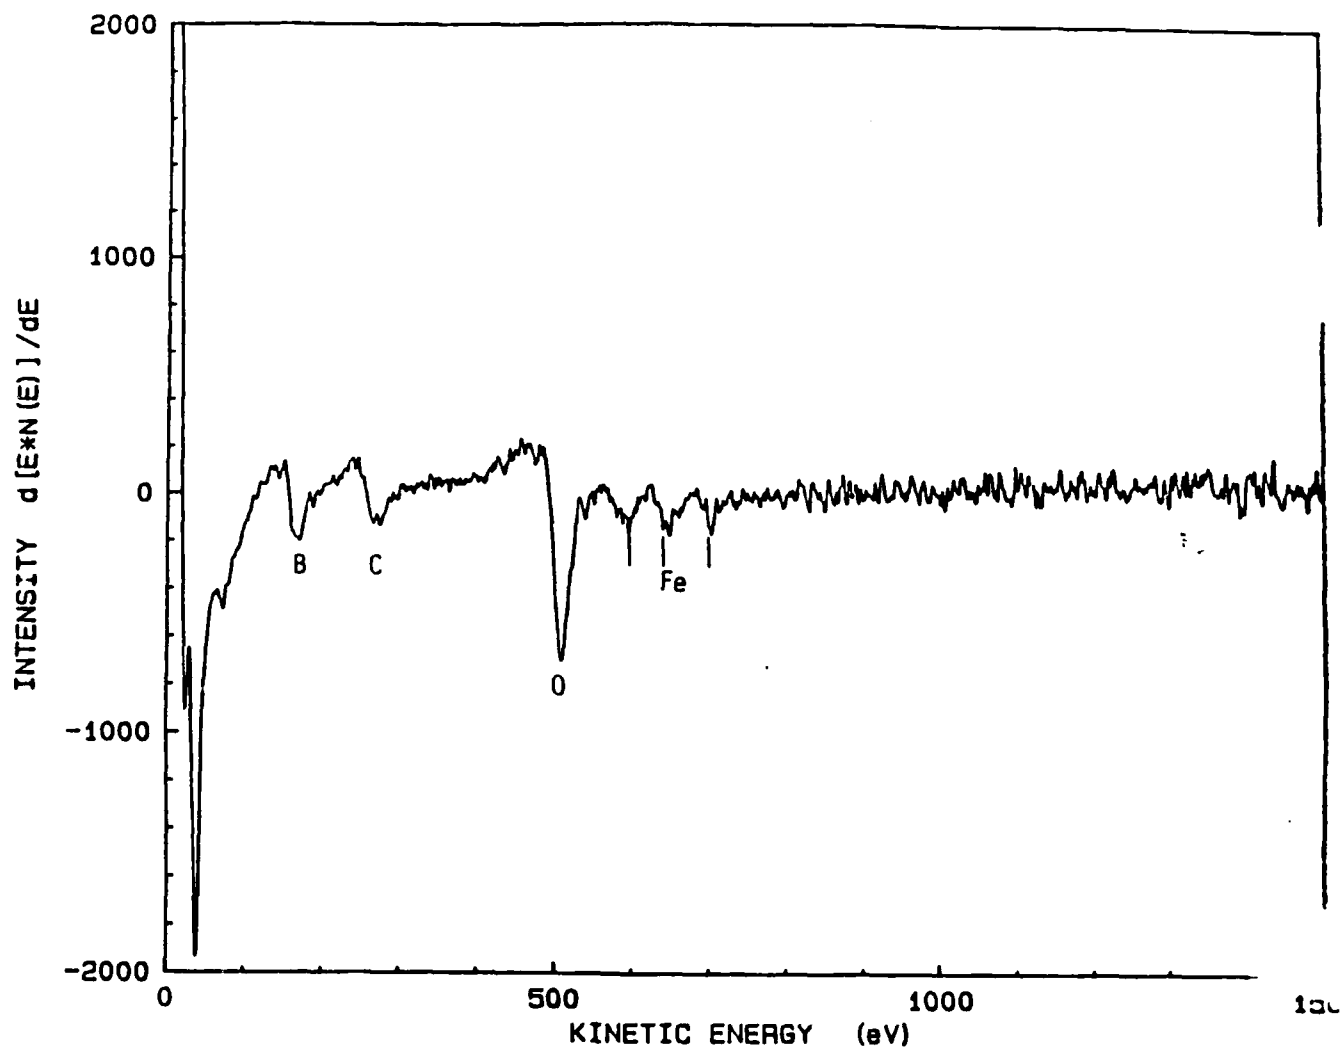
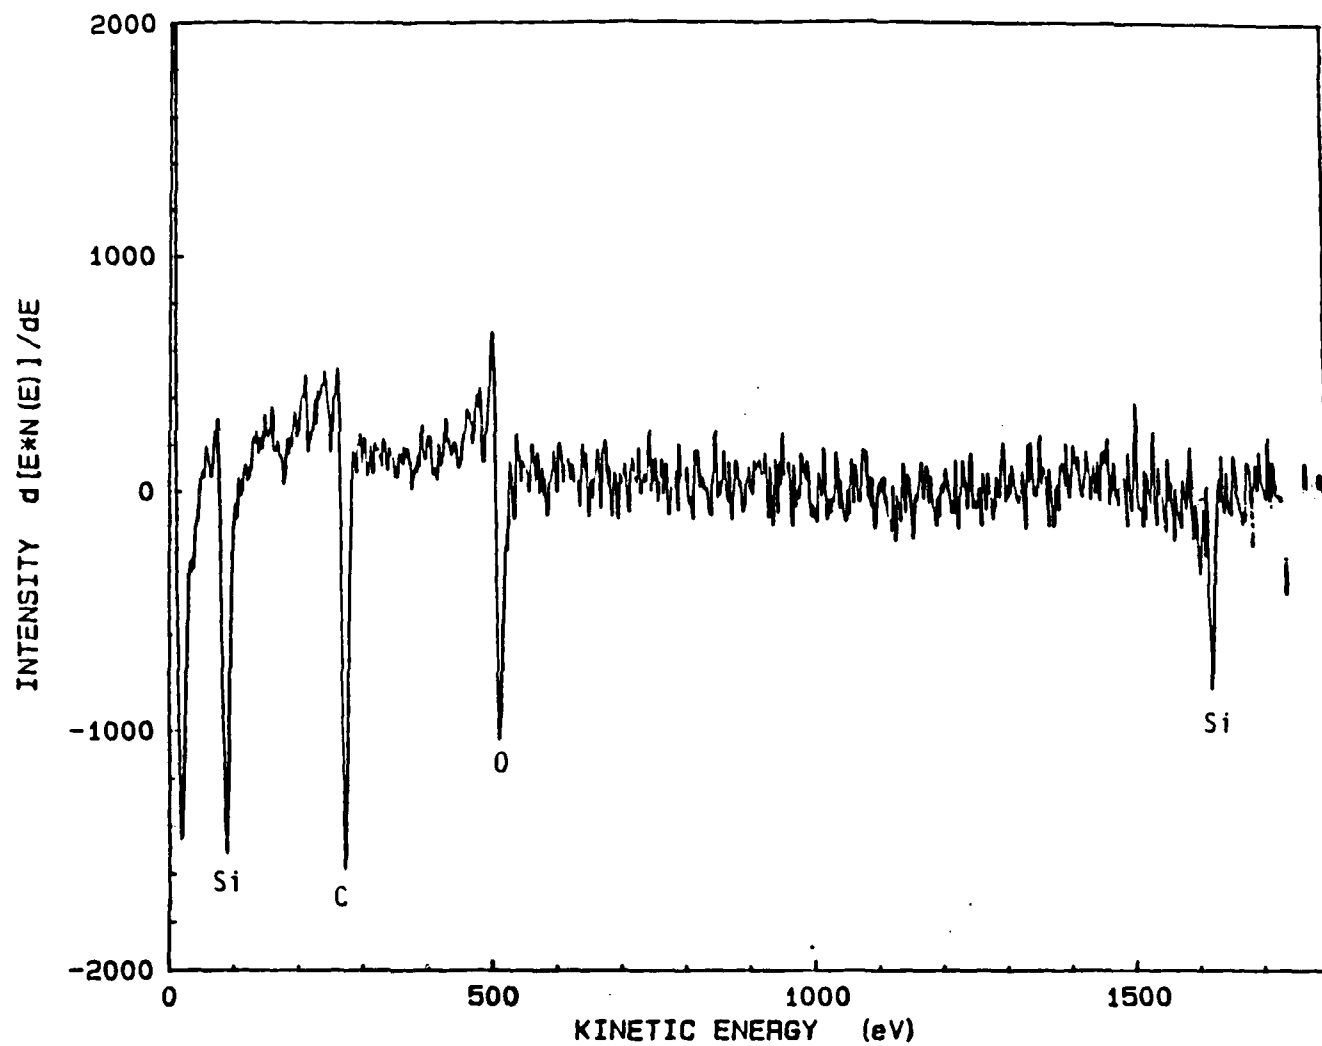
The results of the XRD analysis shown in Table 2 confirmed that the bulk porous material was only SiC. The Auger analysis, however, is more sensitive to the lighter elements and indicated the presence of O and B. Figures 27, 28, and 29 are ACS scans taken confirming that the contaminant was B and also a small amount of Fe. At the time, the presence of boron was not understood until it was discovered that boron carbide (B_4C) was used as the cutting agent in the ultrasonic machining operation. Figure 30 shows two regions investigated. Region 1 was a fracture area of a machined SiC post and region 2 an area of white "deposit". Figures 31 and 32 are magnified areas of regions 1 and 2, respectively.

Figure 27. Laser mirror mount contaminated region 1.

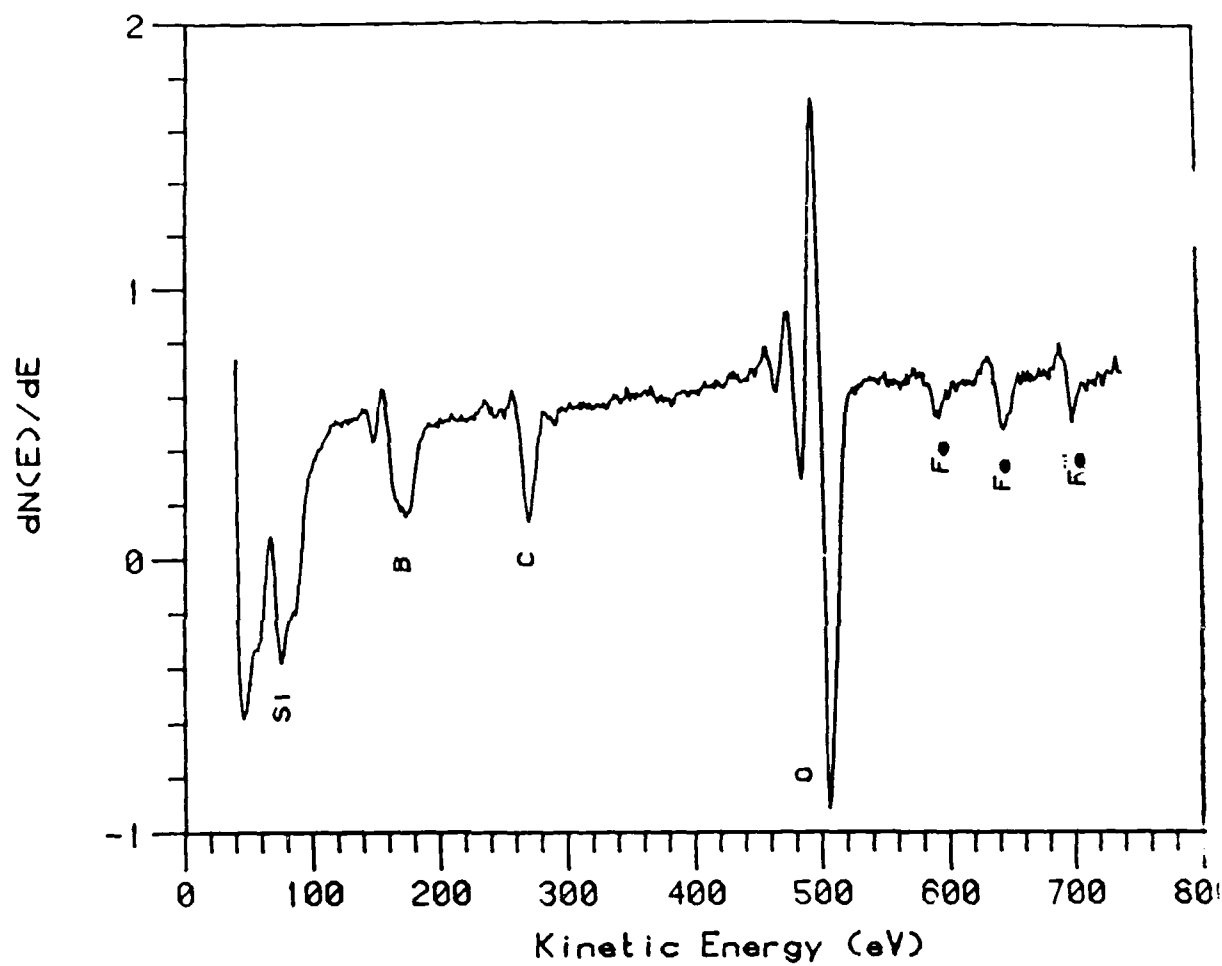
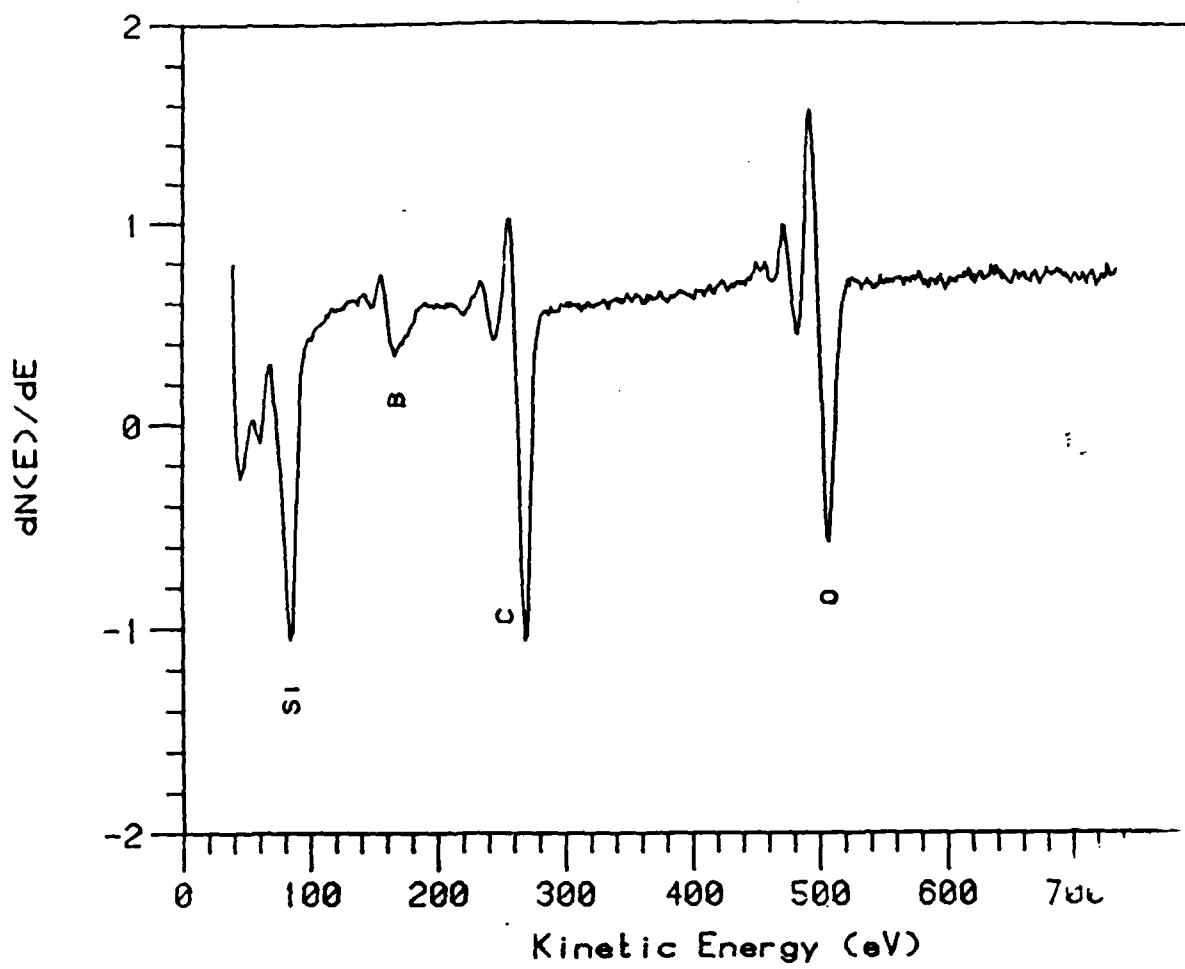
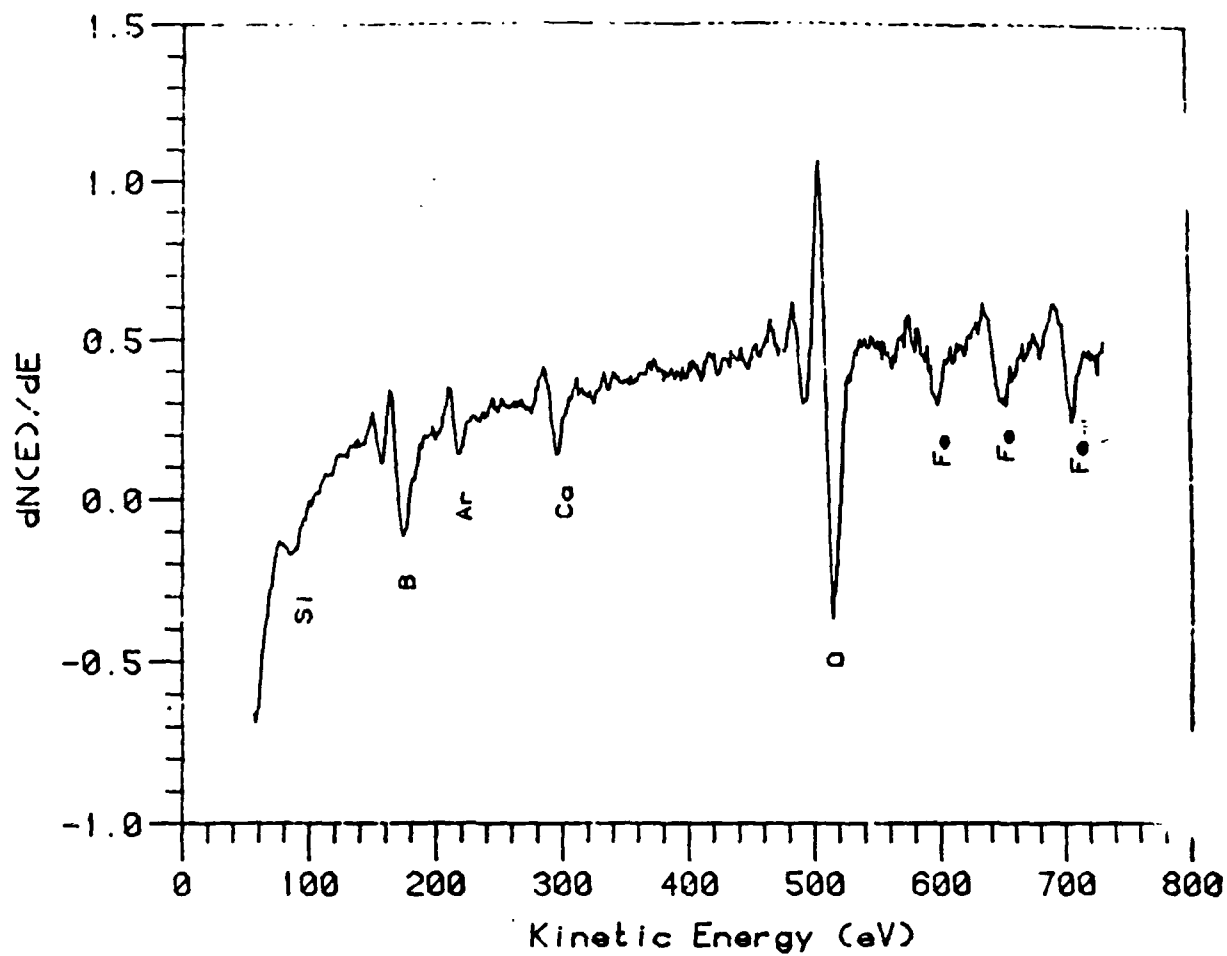
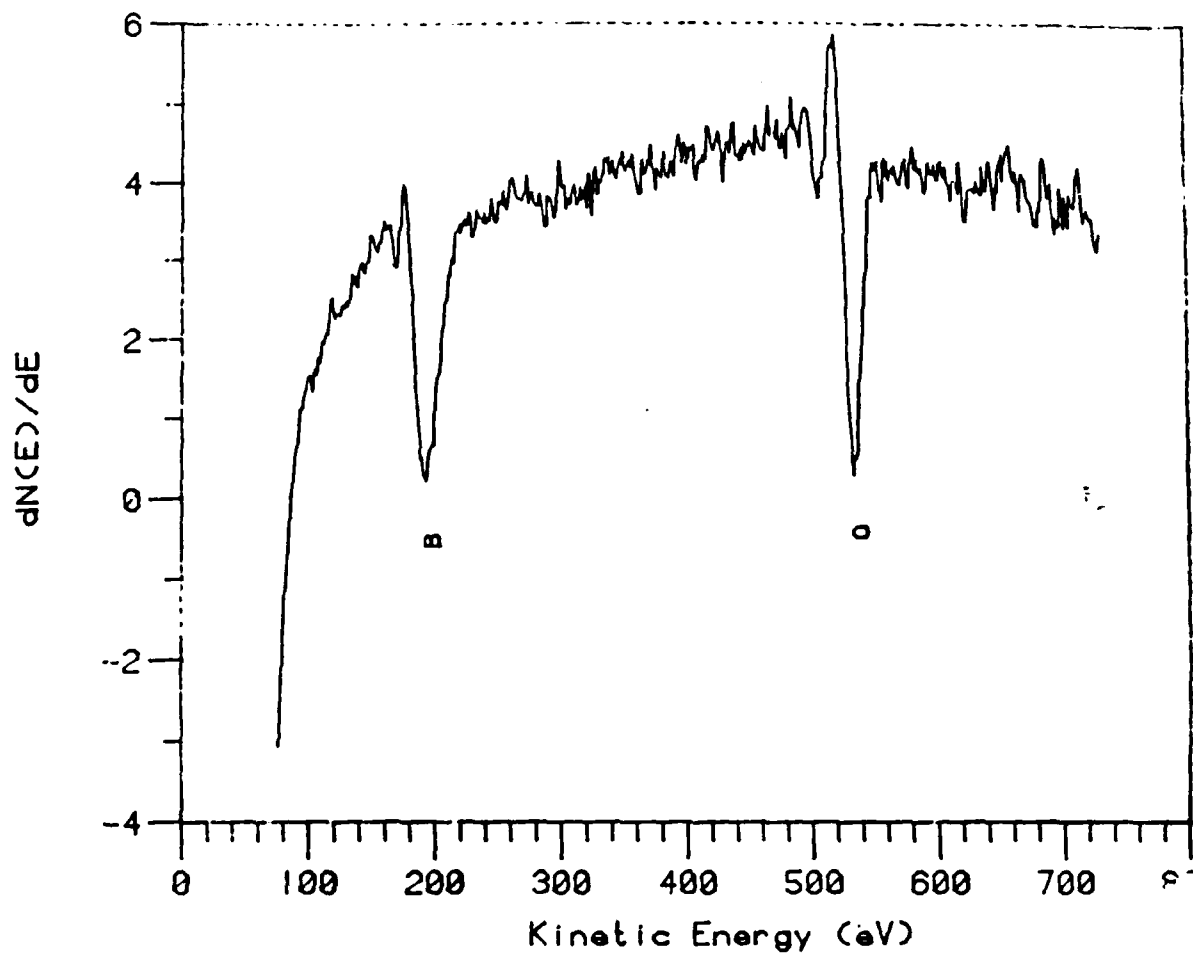
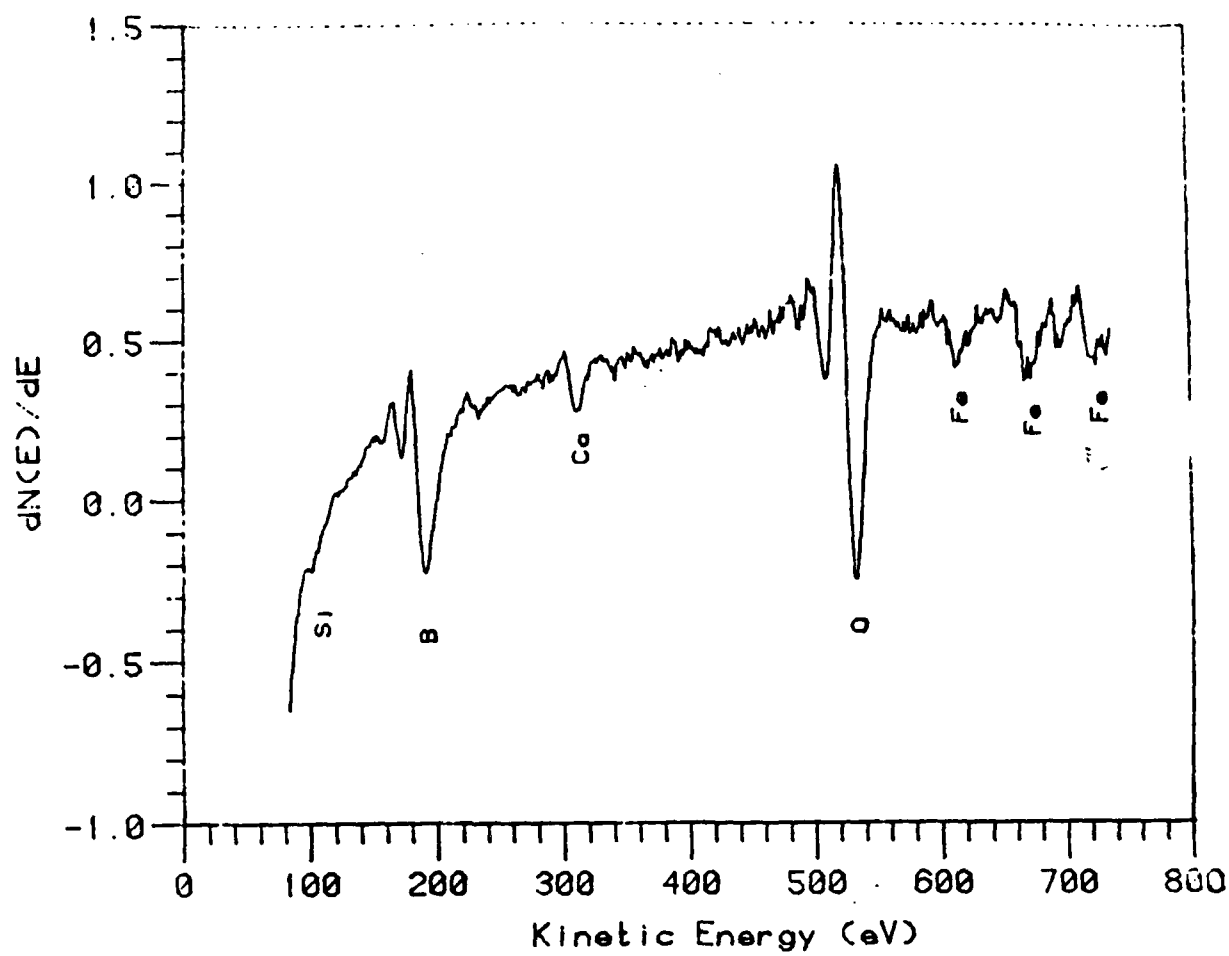
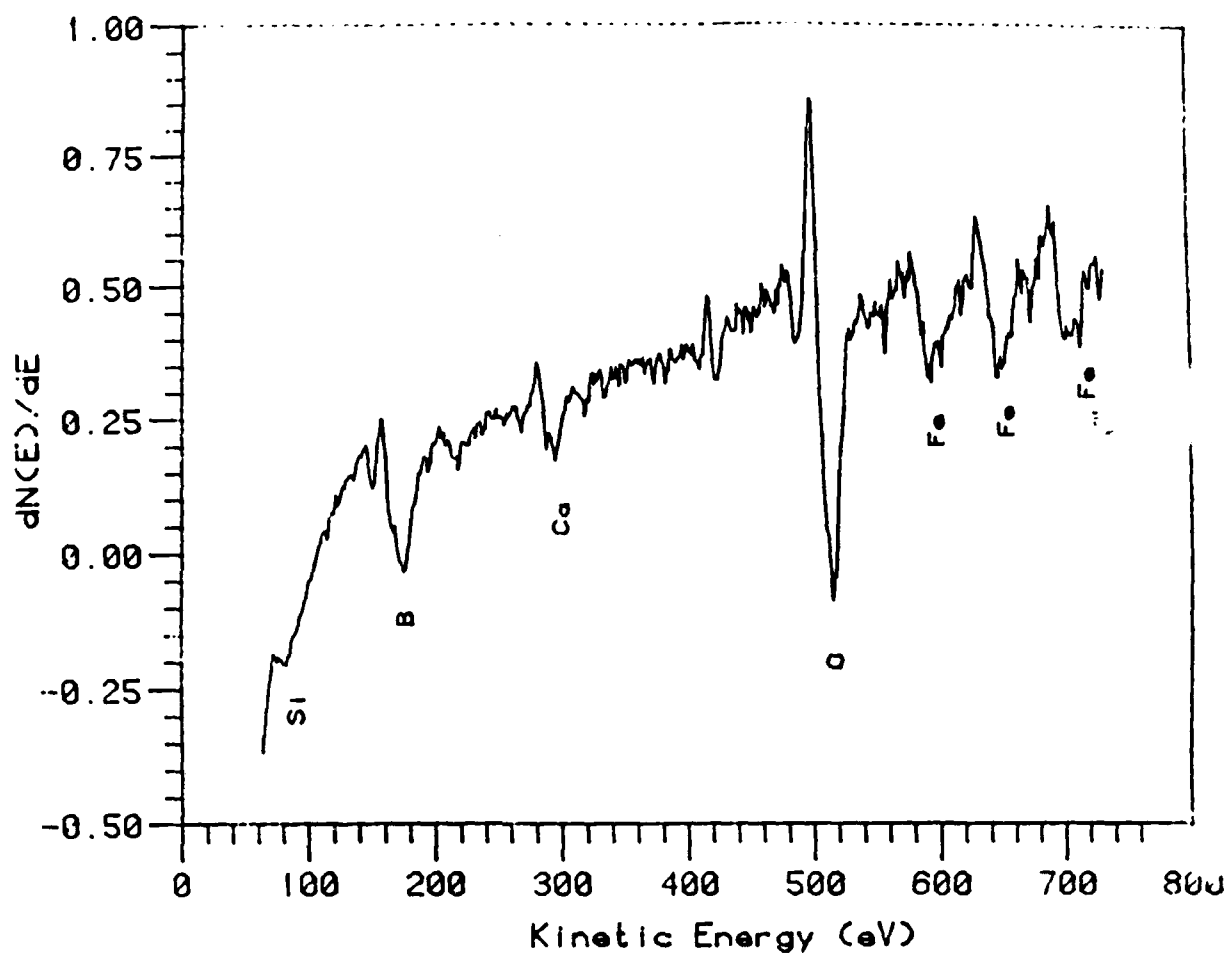
Figure 28. SiC piece next to region with pin broken off AES scan.
